# INVESTIGATION OF THE CONSTRUCTION OF A 19<sup>TH</sup> CENTURY WOODEN FLUME SUSPENDED ON A CLIFF

*The Hanging Flume near Uravan, Colorado, U.S.A., is an engineered structure from a brief but important period in the development of the American West. Constructed during the 1880s for hydraulic mining of gold, the ditch and wooden flume extended approximately 20 kilometers, at times suspended up to 75 meters above the Dolores and San Miguel Rivers on the face of a sandstone cliff, all for the purpose of transporting water. Preserving this innovative construction technology and documenting its place in the development of gold mining the U.S. is challenging. A team of archaeologists, engineers, industrial rope climbers, a wood scientist, a geologist and historians participated in preliminary documentation of the site. Unless remaining sections of the Hanging Flume are documented and stabilized while they are relatively intact, this unique structure will continue to deteriorate until evidence of its innovative building technique and details of its construction are lost forever. This presentation will discuss the use of industrial rope climbers and video equipment suspended from above t

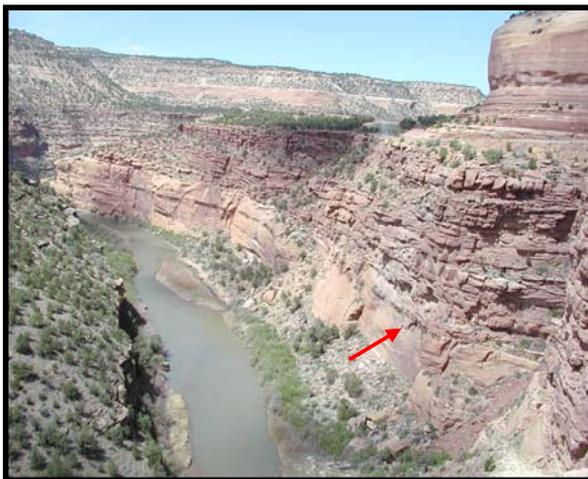
**Figure 1.** View of the Hanging Flume above the Dolores River. The arrow points to only one of the Flume segments which can be seen in this photo.

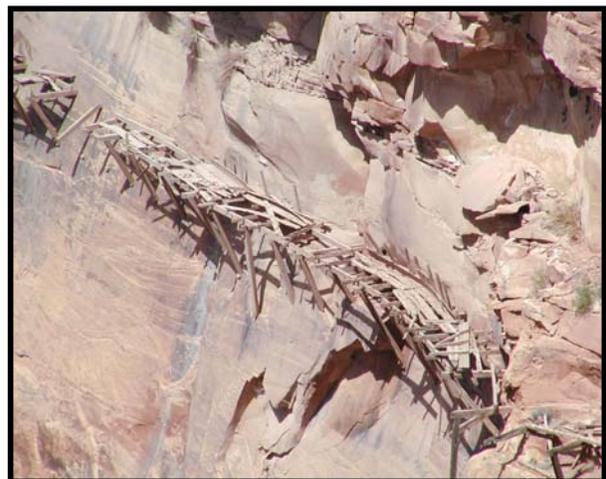
**Figure 2.** Section of the Flume showing deteriorated condition in 2002 (near location of arrow in Figure 1).

The Hanging Flume is in poor condition and is deteriorating. Where protected from the effects of weather or debris falling from above, large support timbers remain. Segments which were accessible had timbers sawn off and boards scavenged for local construction and mining. Where access was more difficult, even the boards remain. From these protected segments were obtained dimensions, wood species, connection types and construction details.

The Flume, constructed with locally harvested Ponderosa pine (*Pinus ponderosa*), used structural timbers for support, boards to serve as the liner for the Flume, iron rods and metal fasteners. The timbers still in place are deteriorating due to weathering, decay fungi and minor insect attack. As the decay progresses, the timbers eventually fall from the iron rods that hold them to the rock face. Numerous timbers are still in place but severely deteriorated, the result of non-durable wood being exposed to moisture for over a century. Water collects on the upper surface and in the checks and splits in the timber, creating conditions favorable for decay. Decay can also be found at connections where moisture is retained within the timbers. Timbers that are somewhat sheltered from rain and snow have performed admirably considering their exposure and the lack of maintenance since construction of the Flume.

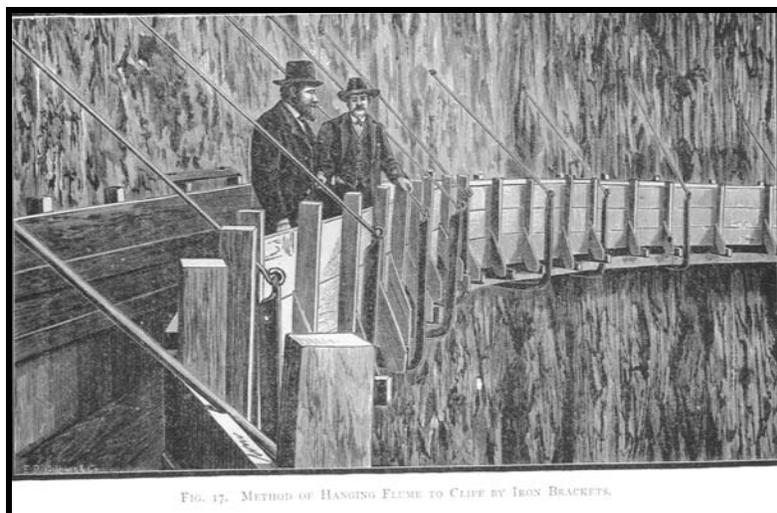
The technique for hanging a flume on the side of a cliff was developed in California. Called a bracket flume, or hanging flume, construction was quite dangerous and required precision work to maintain the grade. Most notable of the bracket flumes was the Miocene Flume in California (Figure 3). Designs varied but were remarkably consistent, probably due to the limited number of engineers and builders familiar with their construction. No as-built drawings of the Hanging Flume are known to exist. Along its length, the structure is intermittently ditch, wooden flume and hanging flume.

**Figure 3.** Miocene bracket flume (hanging flume), California, c. 1881 (Chico State University archives).

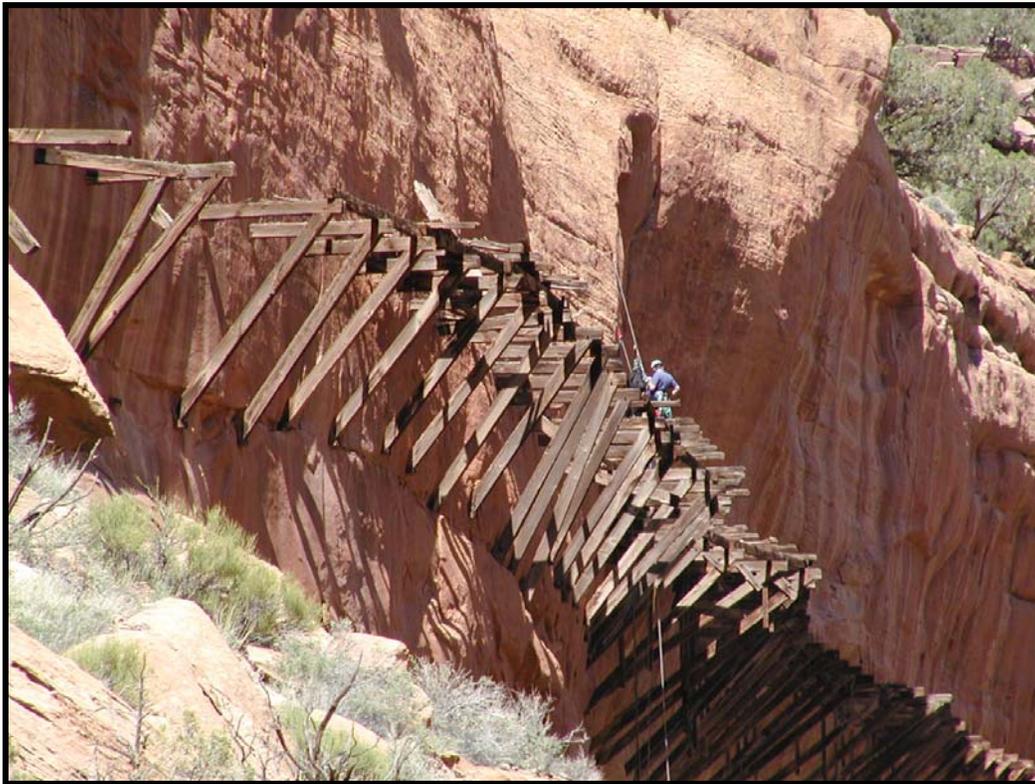
The hanging portions of the Flume are supported on a predominantly vertical cliff face above the Dolores and San Miguel Rivers, so rappelling provides the only means of access to the structure (Figure 4). Structural engineers from Robert Silman Associates, P.C. (RSA) were assisted by the industrial climbing team from Vertical Access, LLC (VA). The survey routine generally consisted of one RSA engineer rappelling down to the structure with one VA technician. The RSA engineer measured and sketched key elements observed at the location (known as a “drop”). The VA technician assisted in taking measurements (Figure 5), took medium format photographs, and operated a video camera with a live feed to a station “topside” (above the top of the cliff face).

**Figure 4.** Engineers and industrial climbers rappel to a relatively intact section of the Hanging Flume.

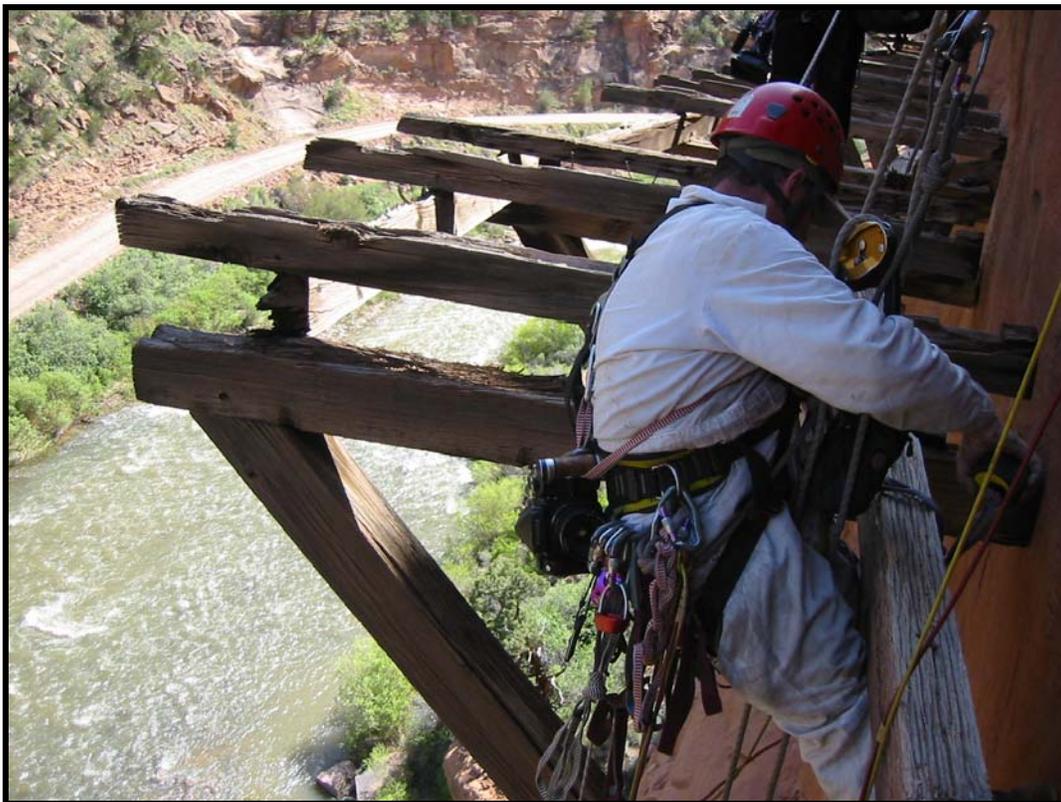
**Figure 5.** Engineers and industrial climbers measure and document the Hanging Flume at a drop site along the San Miguel River.

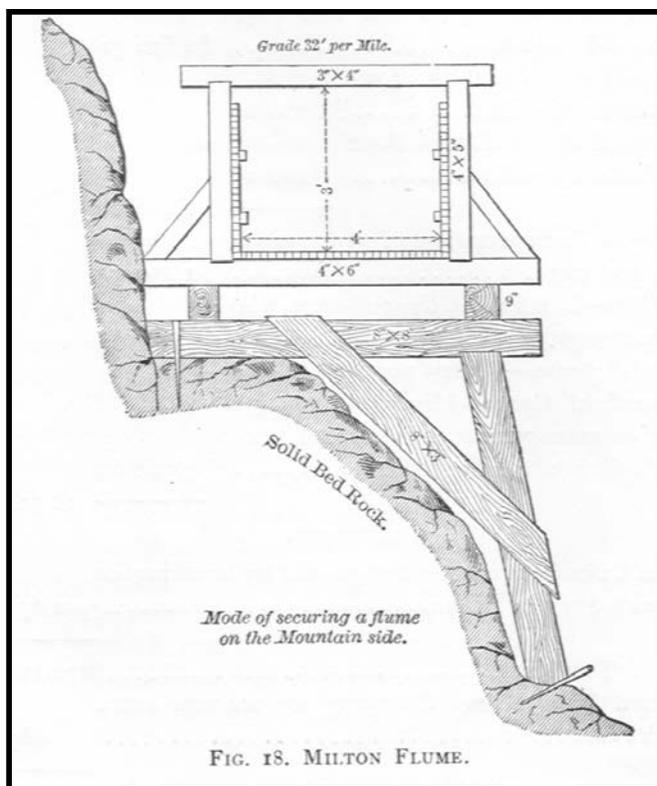
Despite the differences between types, construction of the flume box from the bent upward seems to have been relatively uniform along its length. It also strongly resembles some earlier California flumes documented by mining engineer August Bowie, Jr., in his *Practical Treatise on Hydraulic Mining in California* (Bowie, 1885), so the team decided to use Bowie’s terminology in describing the Uravan flume (Figure 6).

**Figure 6.** Drawing of typical wooden flume, Milton Flume, California (Bowie, 1885).

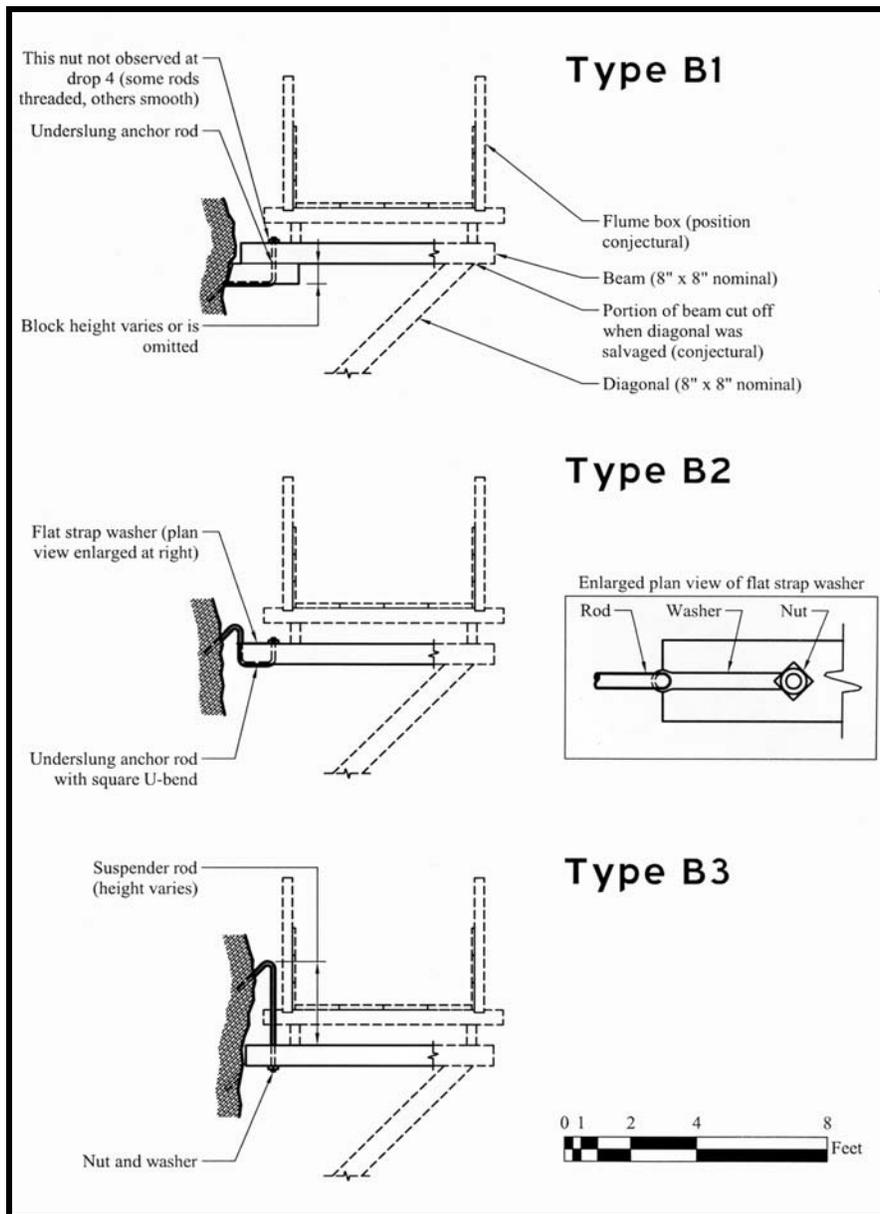
Type B brackets, illustrated in Figure 7, are the most simple, consisting of a metal anchor rod at the cliff face, a horizontal beam, and a diagonal brace extending downward. At least three variants of anchor rod configuration were used, one of which used a flat strap washer (Figure 8). Structural analysis of this type is straightforward because the horizontal beam is supported in just two places. If the anchor rod connection and the beam-brace connection are considered to act as “pinned” supports, capable of transferring vertical load but free to rotate, the load going to each can be calculated by hand using arithmetic. In reality, these supports offer some resistance to rotation, but due to the crushing of timber against the fastener, that is not a reliable load transfer mechanism.

**Figure 7.** Diagram of type B brackets found along the Hanging Flume.

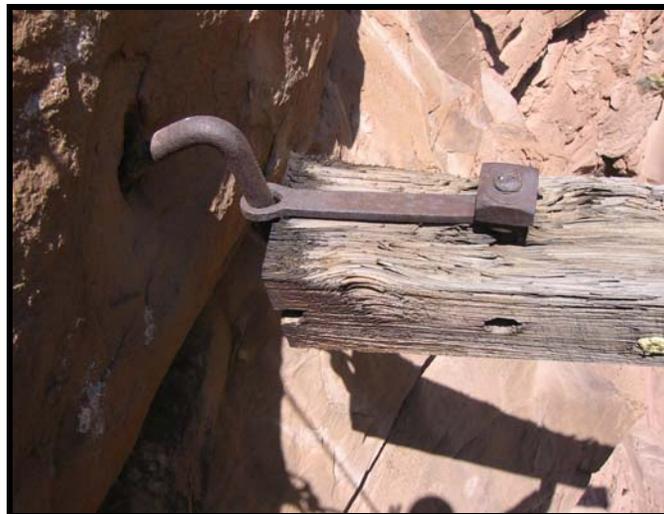
**Figure 8.** Anchor rod configuration using a flat strap washer.

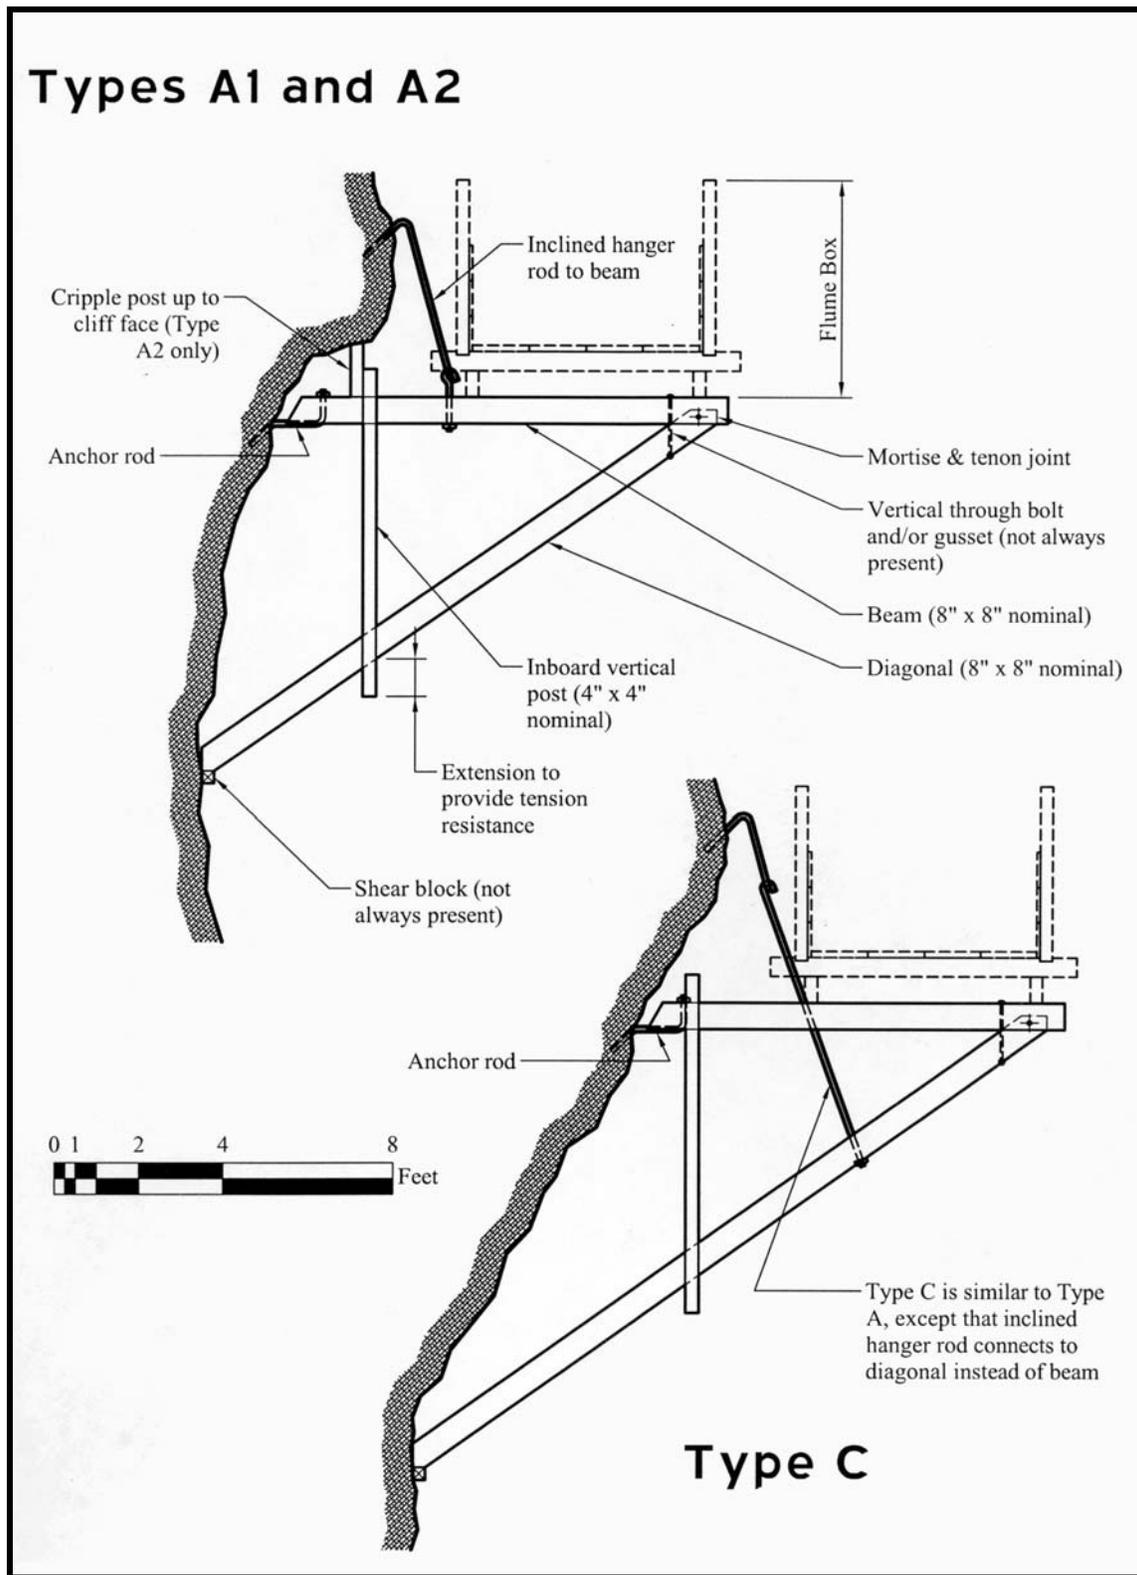
In type A brackets, illustrated in Figure 9, the beam is supported in three or more places. Like type B, there is a metal anchor rod at the inner end of the beam, connecting it to the cliff face. At most type A brackets, the cliff face includes an overhang or projection that prevents the flume box from being located immediately next to the anchor. In response to this condition, type A has another metal rod attached to the beam closer to the flume box and anchored into the cliff face some distance above it. This supplemental inclined rod acts as

an intermediate support, reducing the beam's span and its maximum level of bending stress. While this third point of support makes the division of loading a more complex calculation, it is safe to say that the supplemental rod takes approximately half of the vertical load.

**Figure 9.** Diagram of type A and C brackets found along the Hanging Flume.

Due to the relative stiffness of the beam, the supplemental rod in type A brackets also becomes a fulcrum: as the beam's outer end deflects downward, its inner end pivots upward, exerting an uplift load on the cliff-face anchor. Type A2 is a more effective variant of this design wherein the inner end of the beam has a timber block wedged against the overhanging rock. The block effectively is a fourth point of support, resisting the uplift load in axial compression. Where an inboard vertical post is included on a type A bracket, this post also experiences tension due to uplift. The fact that the post extends past the connection at either end, providing significant tensile capacity, indicates that the flume's original builders anticipated this function.

Type C brackets, also illustrated in Figure 9, appear very similar to type A, but closer inspection reveals that the supplemental inclined rod is connected to the diagonal brace instead of to the horizontal beam (Figure 10). This arrangement represents a far less efficient a use of material than type A. Because it is not directly loaded by the flume box, the brace benefits far less from an intermediate vertical support. Furthermore, because the inclined rod is effective only in tension, it cannot really prevent the diagonal from buckling. The supplemental rod's only useful function is to reduce the diagonal's sag under its own weight. Structural analysis supports this conclusion.

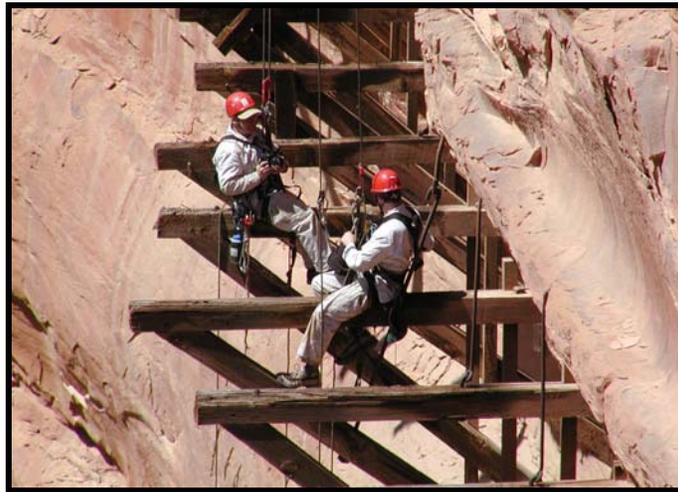
**Figure 10.** An example of type C brackets in a segment of the Hanging Flume.

It seems reasonable to conclude that the supplemental inclined rod was intended to reduce bending stresses in the horizontal beam, as it does in types A1 and A2, and that type C represents a misinterpretation of that intent. The question to be answered in a future reconstruction is whether to preserve such anomalous conditions, which might be acceptable when the flume box is missing or empty, but would exceed modern allowable stress levels under full loading.

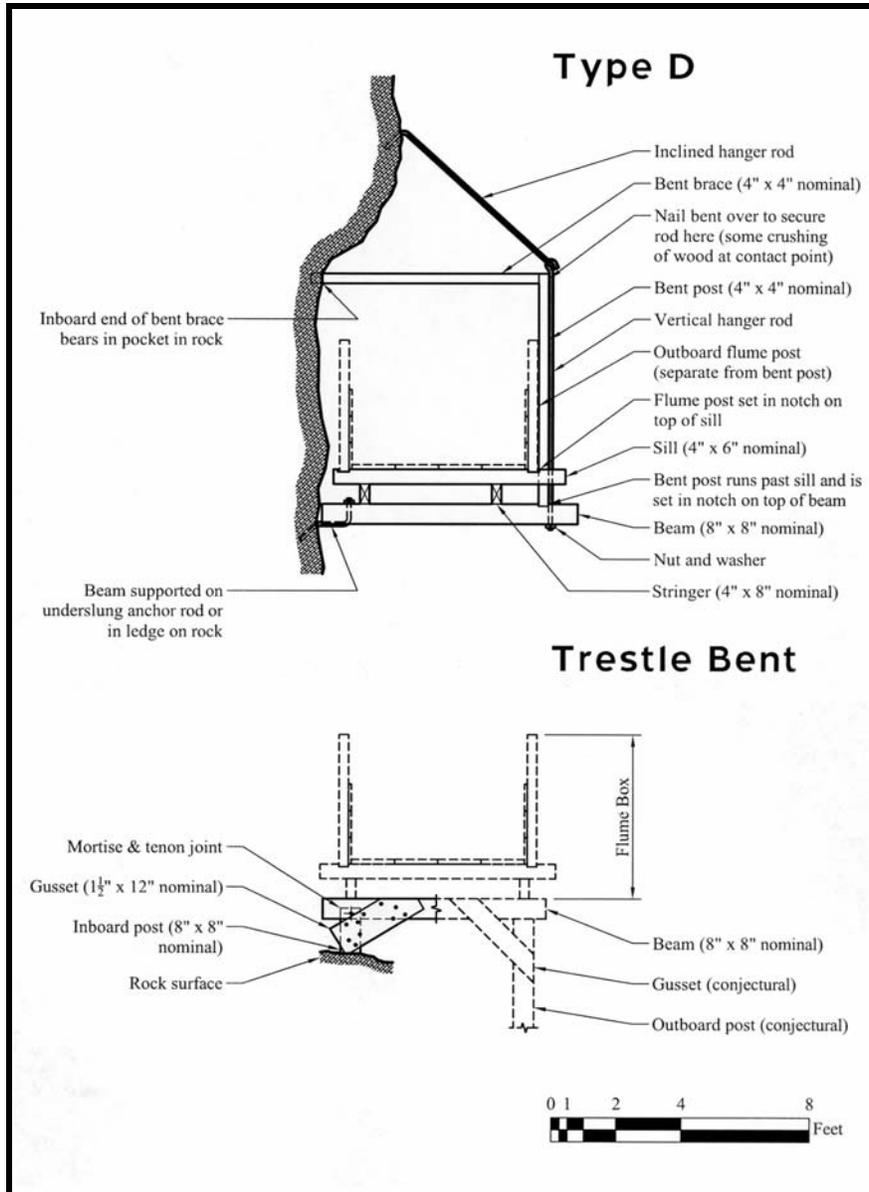
Where the cliff face included a particularly deep overhang, the flume's original builders responded by developing a type of bracket that, more than any other, justifies the name "hanging flume." Because they are not susceptible to buckling, hangers in tension typically are a more efficient use of material than compression elements. Realizing this, the flume's builders eliminated the downward diagonal brace and substituted a hanger rod inclined upward where they felt confident that the overhanging rock could support the flume's weight. The hanger rod could not simply angle upward from beam to cliff face, however, because this would not leave enough room for the flume to pass through. The solution, called bracket type D and illustrated in Figure 11, is for a vertical rod to ascend from the beam to a point above the flume box, followed by a second segment of rod ascending at a steeper angle to the cliff face (Figure 12). The change in angle represents a change in the direction of force in the hanger, which is resolved through two timber elements, a "bent post" down to the beam, and a "bent brace" in toward the cliff face. Because the bent post and bent beam carry smaller forces than the diagonal brace found on other brackets, type D uses less heavy timber, albeit at the expense of greater complexity.

The final type of support observed is a trestle bent, called type T, also illustrated in Figure 11. Trestle bents are structurally straightforward, consisting of a beam and two posts (either vertical or, as in Bowie's drawing of the Milton flume, leaning inward at a slight angle). Timber gussets at each intersection of post and beam provide lateral stability.

**Figure 11.** Diagram of Type D brackets and trestle bents found along the Hanging Flume.

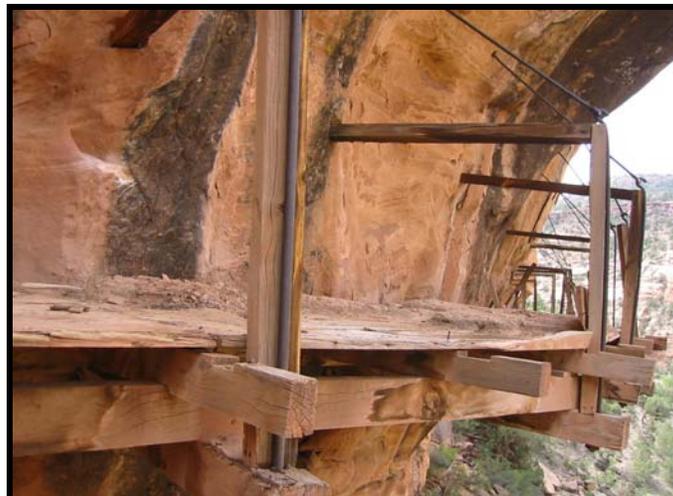
**Figure 12.** An example of type D brackets found in one segment of the Hanging Flume.
